BLACKWELL MINE DAM

Missouri Inventory No. 30709

Phase I Inspection Report

Woodward-Clyde Consultants

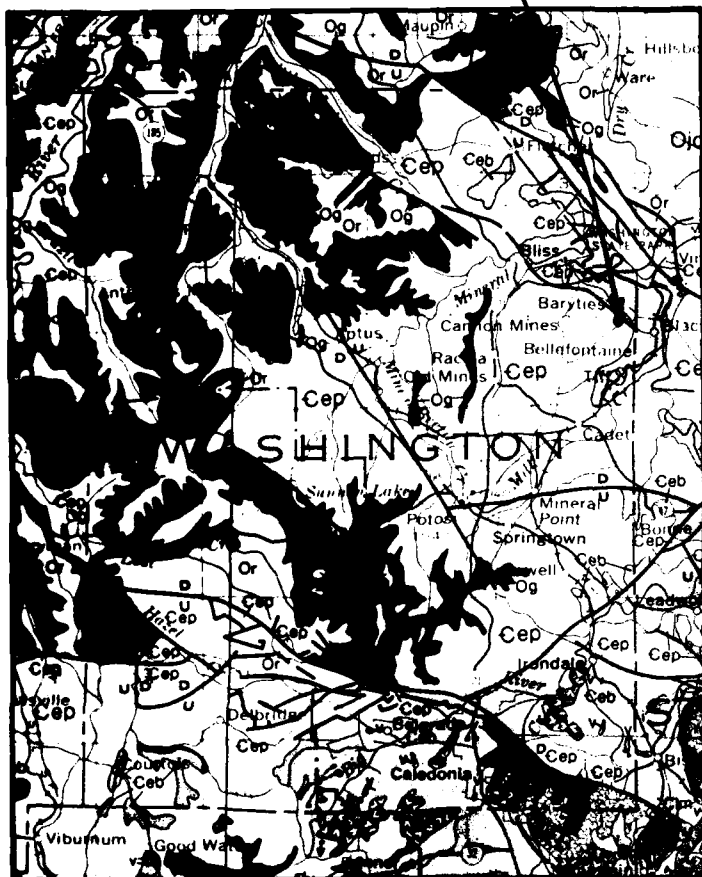
Fig. 4

The Cruise Mill-Fertile Fault Zone is mapped directly beneath the Blackwell Mine Dam (Fig 4). However, the scale of the map (1 inch equals approximately 8 miles) does not allow for precise location of the fault trace. No evidence of the fault was noted during the field inspection. The fault zone is approximately 6 miles long with a northwest-southwest trend, and may connect with the Richwoods Fault Zone, to the northwest, resulting in a zone approximately 15 miles long. The fault is mapped as northeast side up.

A study of Cruise Mill-Fertile Fault zone is recommended. The fault is believed to be in very close proximity to the dam. This study should be done without undue delay.

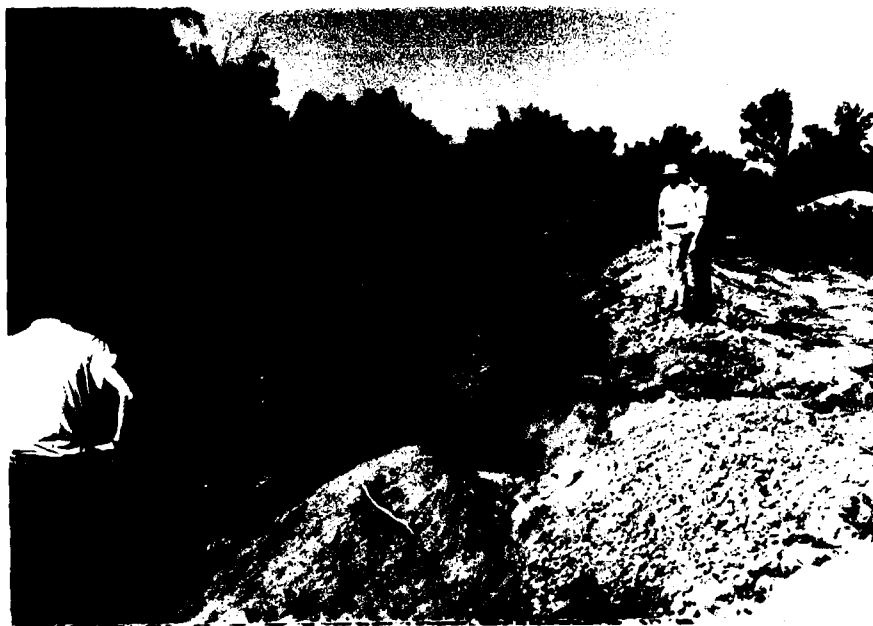
3. Dredge spoil along embankment at east edge of impoundment. Looking southwest, reservoir to the right.
